Final Technical Report

Residential Fuel Cell Demonstration by the Delaware County Electric Cooperative, Inc.

Recipient: Delaware County Electric Cooperative, Inc.
Award Number: DE-FC36-04GO14239

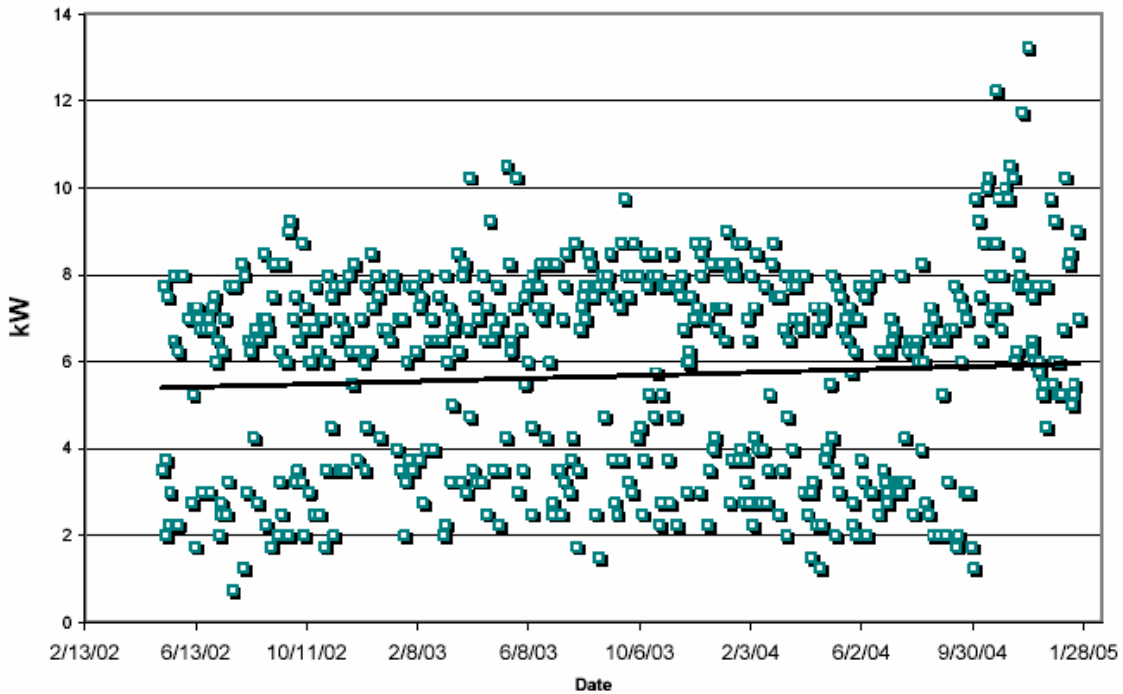
Figure 2 Historical Peak Power Demand for Fuel Cell Host Residence

Although this is a one-year fuel cell project, DCEC has been collecting base load data at the demonstration site for the past three years using 15-minute averaged data supplied by DCEC's automated meter reading system. Figures 2 and 3 display summaries of the home's peak demand and energy consumption data from May 2002 through January 2005.

Based on the historical data, the host residence is trending toward higher peak demands and energy consumption. The addition of a hot tub at the residence during 2004 is responsible for much of that upward trend. Peak power consumption was measured to be approximately 13.5 kW using energy consumed during a moving 15-

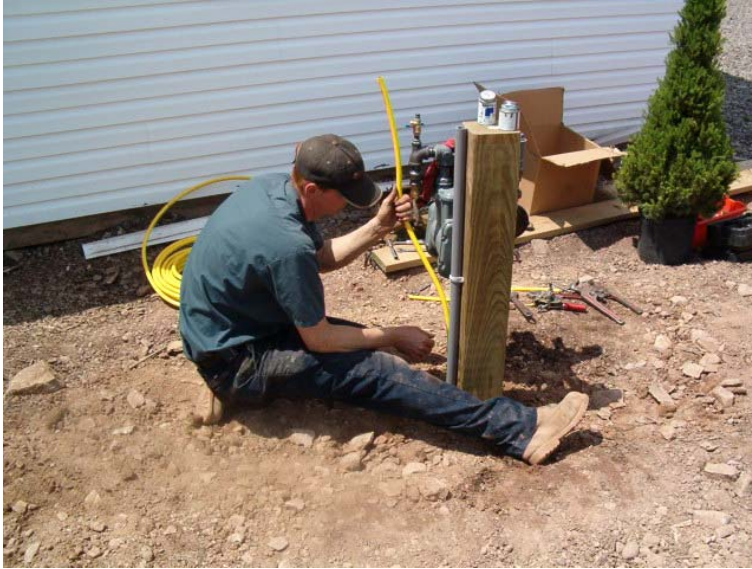
The propane subsystem consisted of a 1000 gallon underground storage tank, buried pipe to deliver the propane to the load, pressure regulation, and a pulse-producing propane meter. In the picture below, an employee of project partner Mirabito Fuel Group is preparing terminations on the pedestal that supported the propane meter and pressure regulator, which was positioned between the underground storage tank and the fuel cell.

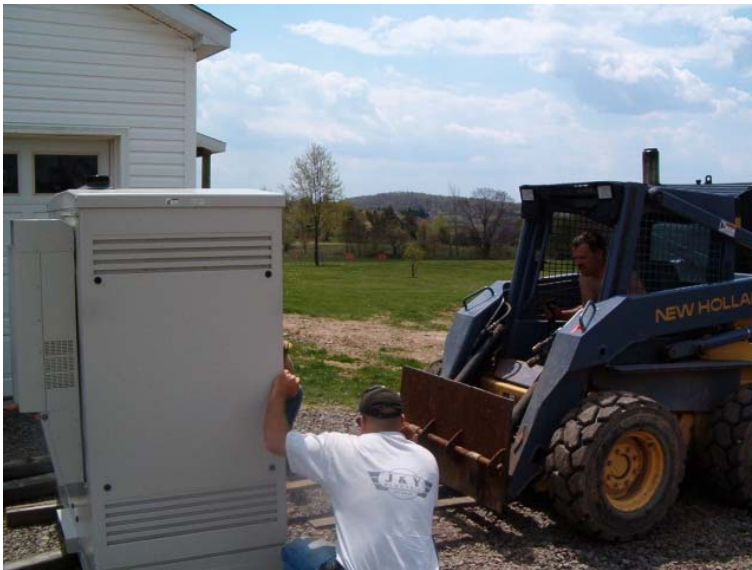
The fuel cell was a Plug Power GenSys propane fuel cell with 5 kW maximum sustained output. The fuel cell was delivered from the manufacturer with a self contained reformer, cell stack, inverter, controller, and battery for black start. The picture below shows the fuel cell being moved into place by DCEC personnel using a leased skid steerer.

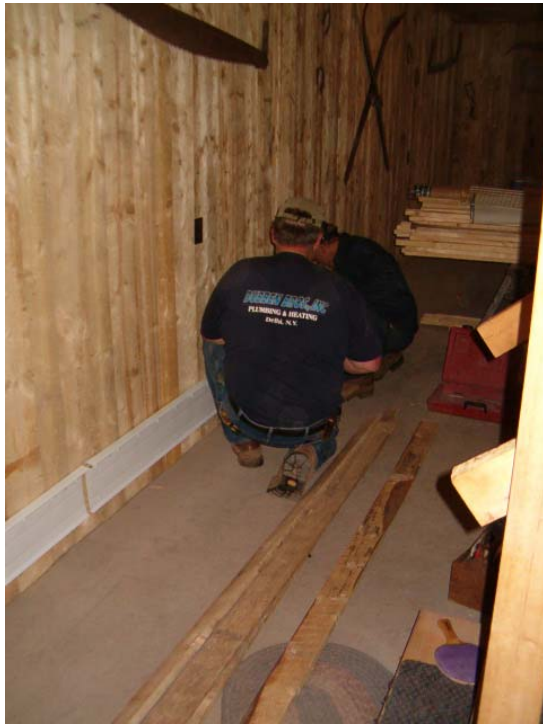
When the thermal recovery system was in its normal state, the glycol/water mixture would circulate through the hot water heat exchanger to preheat the domestic hot water. When the thermostat in the basement called for heat, a diverter valve caused the glycol/water mixture to flow through the baseboard heaters instead of the heat exchanger. The picture below shows employees of Dubben Brothers Plumbing service installing the baseboard heaters in the basement. Due to the fact that the thermal recovery loop operated at temperatures lower than typical baseboard heating applications, very long sections of baseboard radiators were installed in order to get sufficient heat transfer into the room.

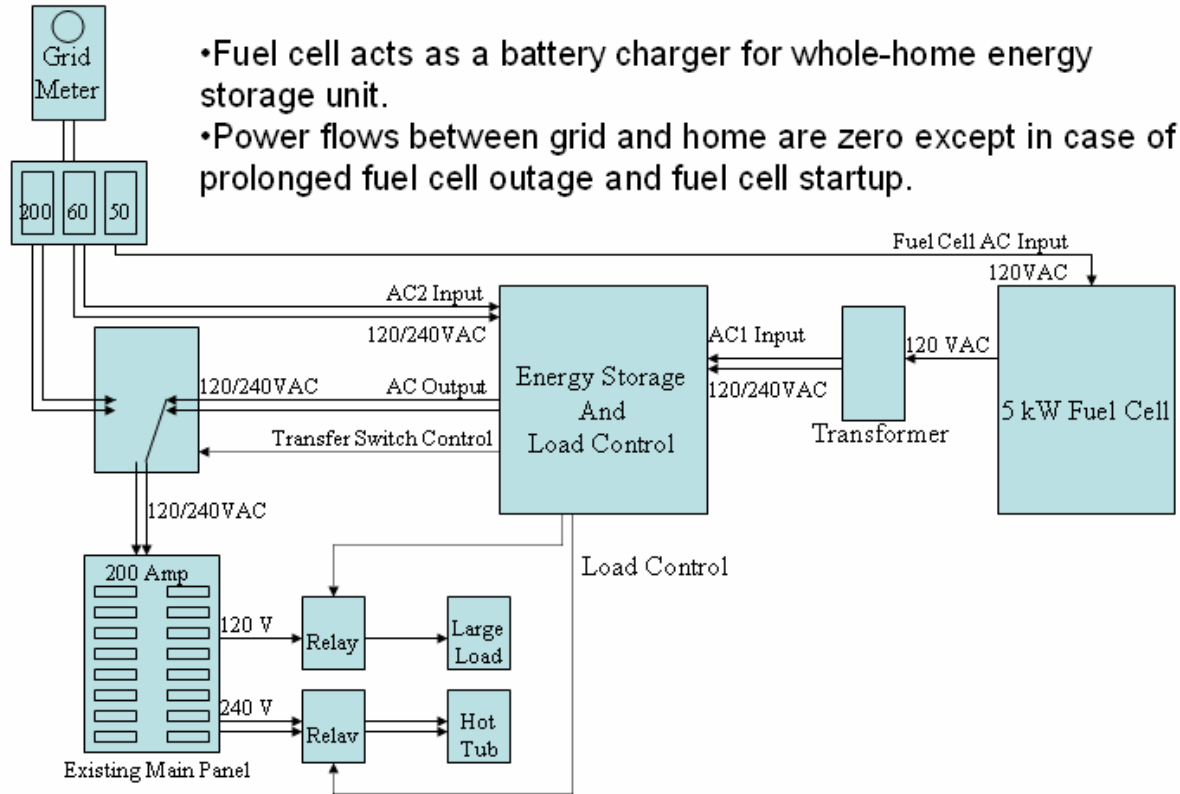
energy storage system. The graphic below is a schematic representation of the electrical subsystem.

- Fuel cell acts as a battery charger for whole-home energy storage unit.
- Power flows between grid and home are zero except in case of prolonged fuel cell outage and fuel cell startup.

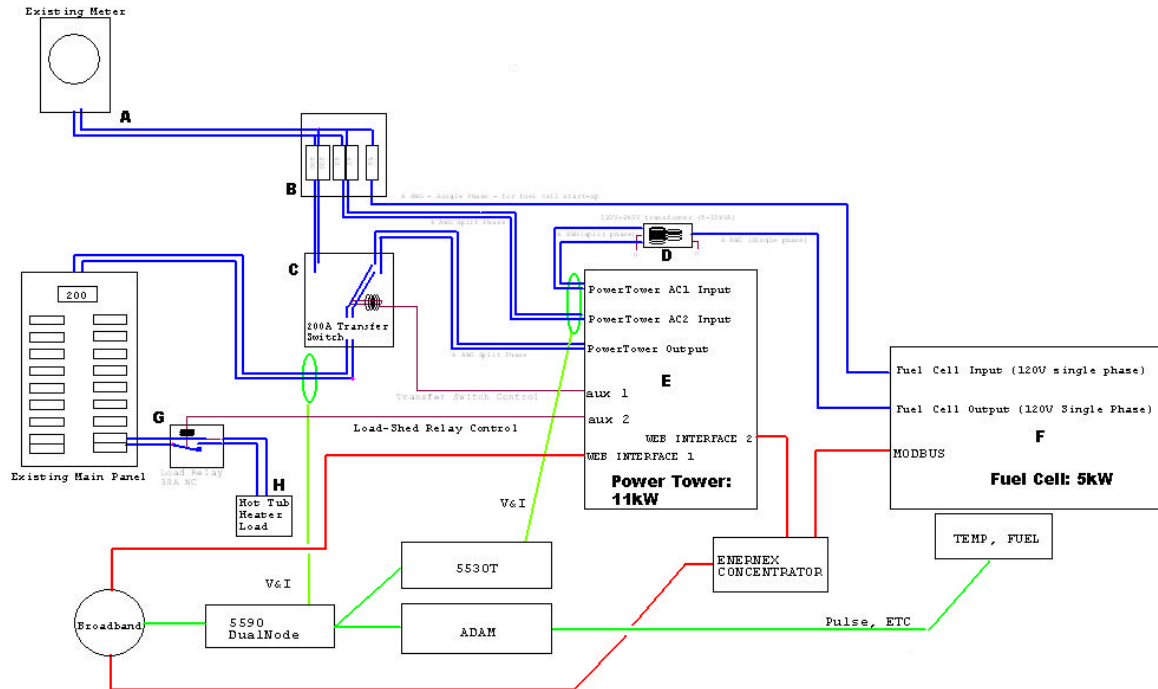
The graphic below is a schematic representation of the data acquisition system employed at the demonstration site.

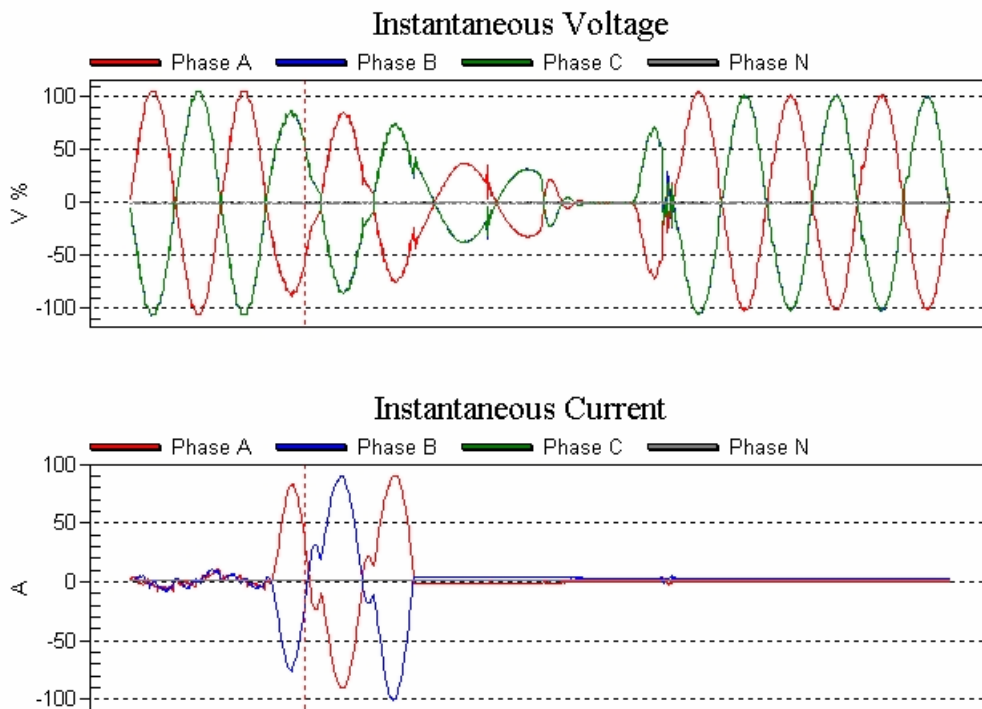
The figure below shows a power quality recording of the input to the energy storage device while it is being fed by the fuel cell through a split phase transformer (120 V – 120/240 V) in response to a large step function in current.

The fuel cell's response to the step function current demand is typical of a weak distributed generation source. This data capture is typical of the recordings of many similar power quality "events" that occurred during the 1-year demonstration period. This recording and many others are available at the project data clearinghouse website hosted by EnerNex Corporation at <http://www.storagemonitoring.com/nyserda-doe/>. Other forms of power quality events captured and available on the website include instantaneous swells, transients, instantaneous sags, and temporary interruptions.

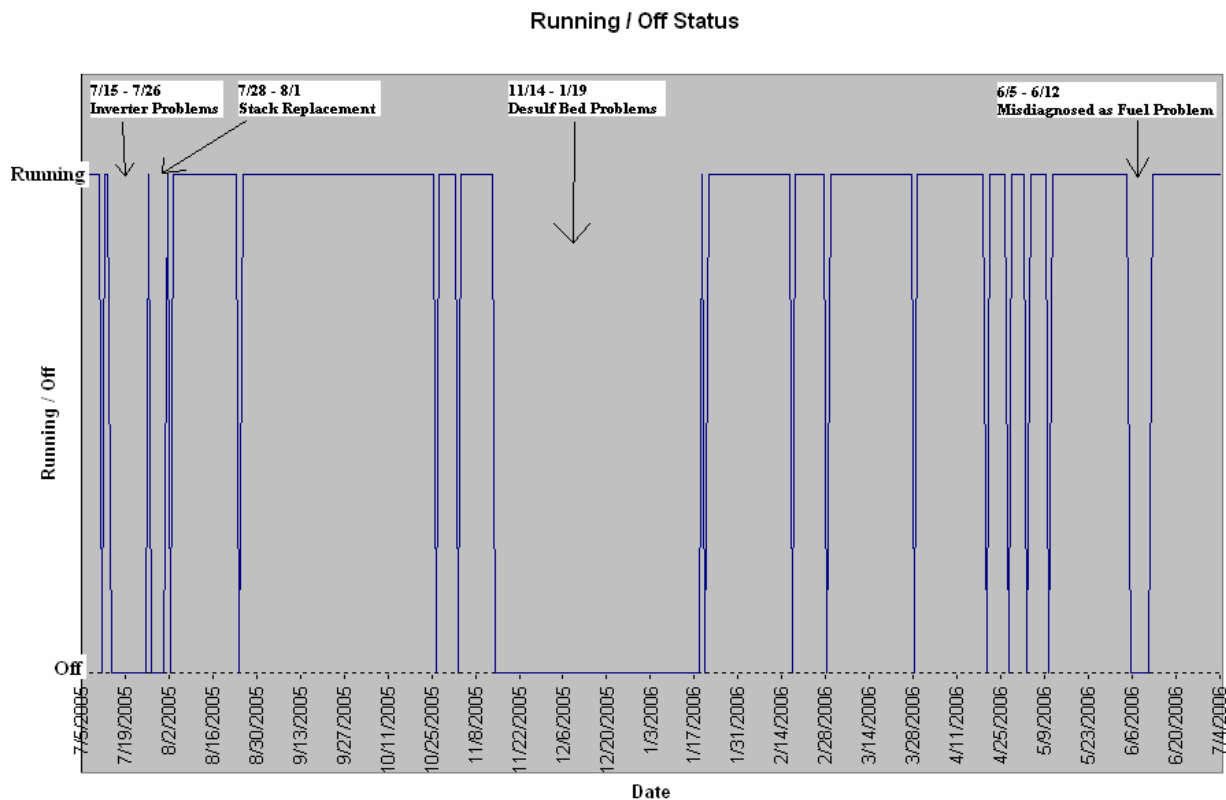
The Plug Power GenSys 5 kW propane fuel cell was running and providing power 71.8% of the one-year demonstration period. The figure below shows the periods during which the fuel cell was running and when the fuel cell was off. The fuel cell was run at all times when it was available to run, so percent run time is equivalent to percent availability in this case.

The fuel cell shut down a total of twenty-four (24) times during the 1-month commissioning period and the 1-year demonstration period. Appendix B to this report lists each of the 24 shutdowns, the error message associated with the shutdown, the time to recover from the shutdown, and any intervention required in order to restore the fuel cell to an operating state. There were only four periods during the 1-year demonstration period during which the fuel cell was unavailable for more than 1 day. Each of those outages lasting more than 1 day is noted on the figure above.

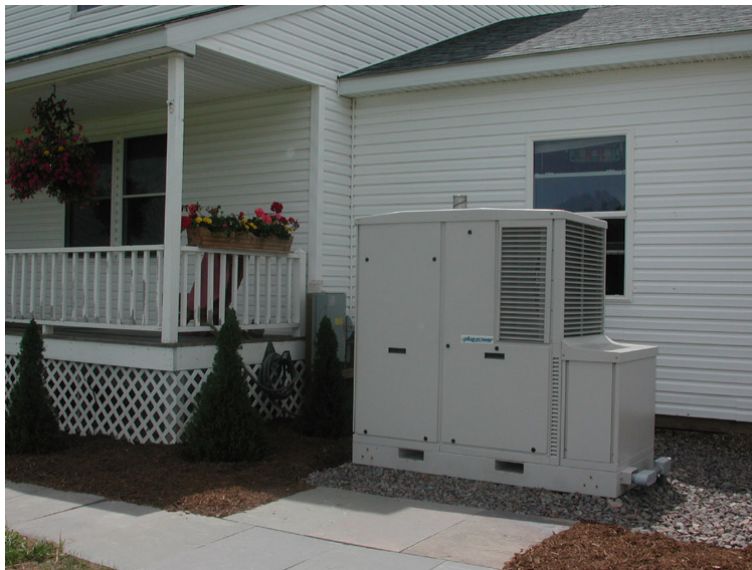
The fuel cell operated in the full range of Upstate New York weather conditions without any damage or apparent degradation of performance. The fuel cell operated in a minimum ambient temperature of -10.7 degrees Celsius (12.8 degree Fahrenheit). The temperature gauge that recorded ambient conditions was located in close proximity to a protected corner between the main part of the host residence and its attached garage. The fuel cell was also located in this semi-protected area. Although lower outdoor temperatures were experienced in the vicinity of the residence during the demonstration period, the fuel cell itself did not experience temperatures lower than 12.8 degree Fahrenheit. The picture below shows the semi-protected corner where the fuel cell and temperature gauge were installed.

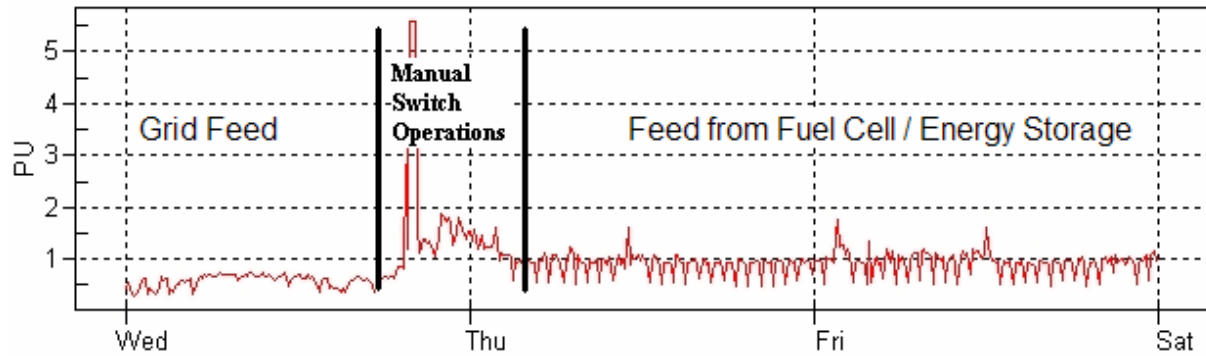
Power quality data and homeowner feedback from the demonstration project provided valuable insights into the impacts of power quality on the quality of life of residents within a home. From the homeowner perspective, the presence of light flicker was the only noticeable impact of power quality problems during the demonstration. The IEEE-defined quantity called short term flicker is a way of quantifying and comparing the flicker phenomenon in a standard and consistent manner. The figure below shows the unitless short term flicker quantity plotted across a period of time that included straight grid-feed to the energy storage device and the fuel cell feed to the energy storage device. The flicker measurements were recorded at the home's main panel, where it is most indicative of the overall flicker level experienced in the home.

Note that the y-axis label of PU stands for “per unit,” which is another way of saying that short term flicker is a unitless quantity. During periods when the utility grid was feeding the energy storage device, the short term flicker values were in the range of 0.5 to 0.8. During the periods when the fuel cell was feeding the energy storage device, the short term flicker values were in the range of 0.5 to 1.5 with frequent peaks above 1.0. By definition, a short term flicker value of 1.0 indicates a level of flicker that would be noticeable to 50% of the human population.

The short term flicker data was corroborated by the experience of the home owner and the project team. During a typical day at the demonstration residence, the home owner met with three other members of the project team. Light flicker was evident or noticeable to the home owner and one project engineer. Two other project engineers could not detect the presence of light flicker. This “subjective” nature of flicker impacts makes this issue even more important to equipment manufacturers, resellers, and installers. Flicker must be assessed and addressed through objectively quantifiable means because each human will experience flicker to a different degree.

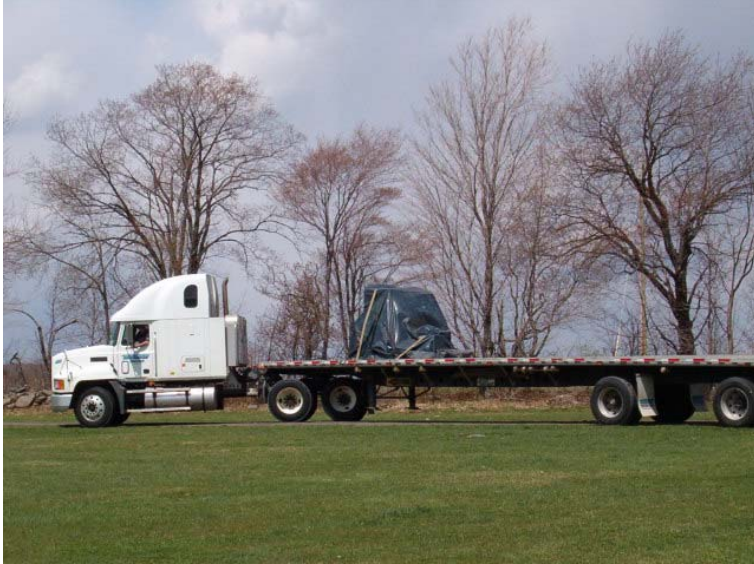
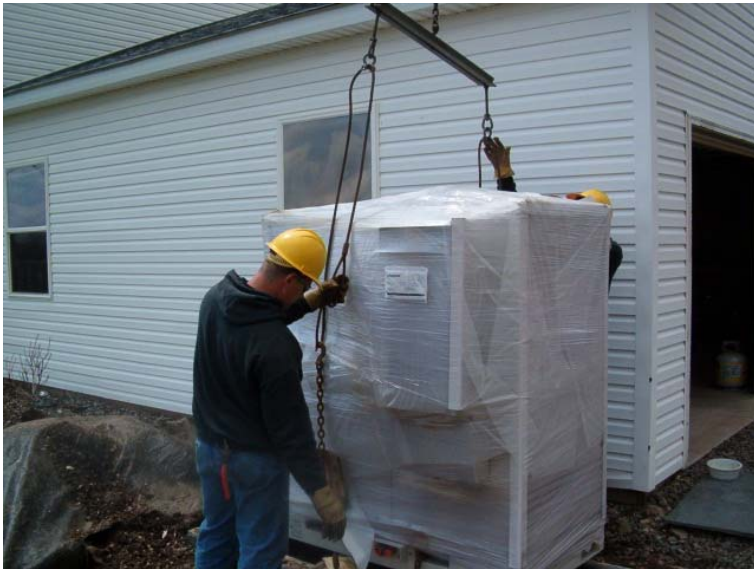
- Installed Signature Systems Dual Node PQ Monitoring device on main panel
- Problem with CT clamp size
- Unloaded fuel cell and placed on cross arms adjacent to planned installation location

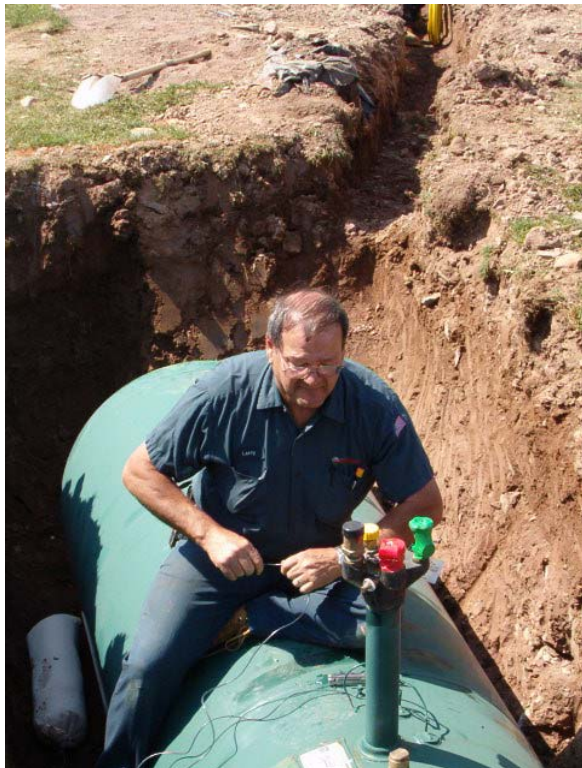
- Finished excavation for 1000 gallon propane tank
- Set tank with larger excavator from Walton Highway department
- Laid in sand in fuel line trench and around propane tank

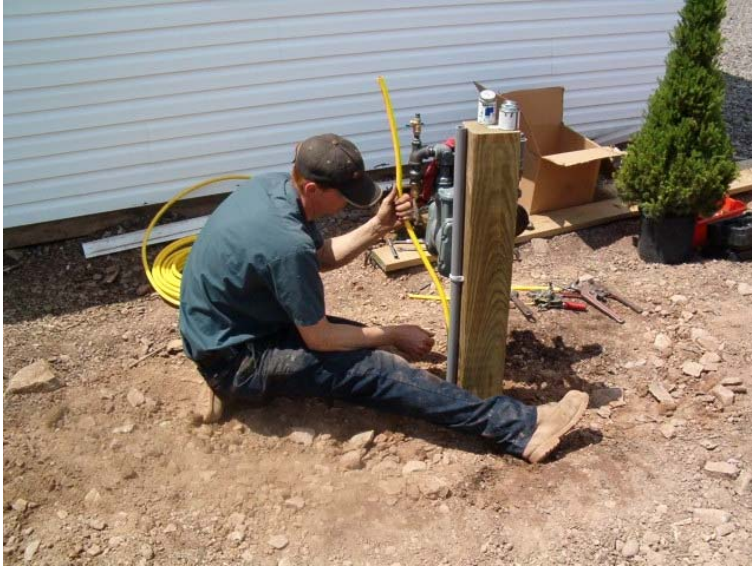
- Mirabito hooked up gas line – tested OK

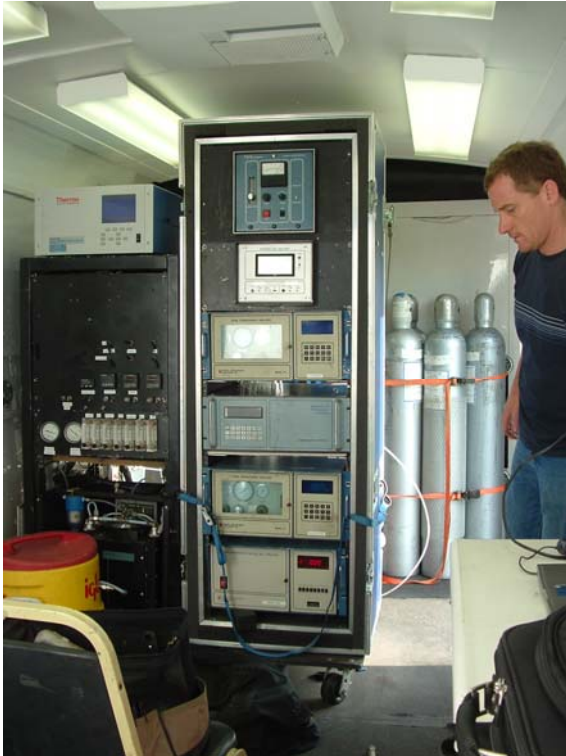
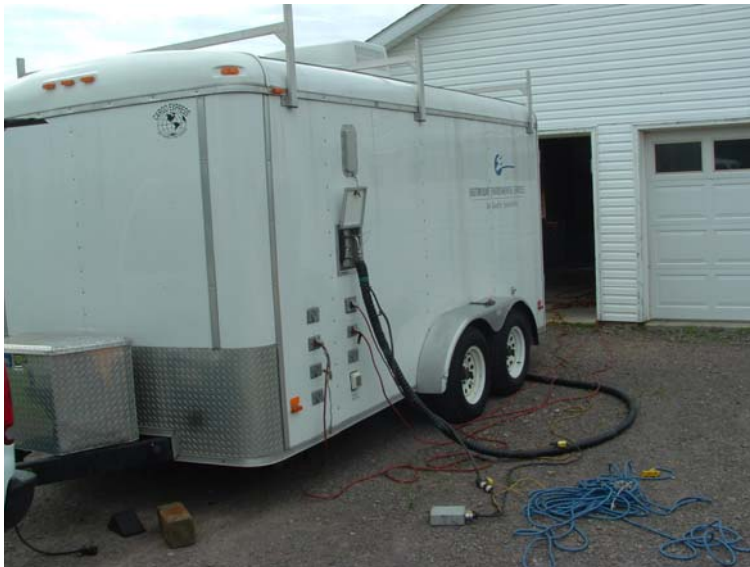
- Arrived ~7:45 AM
- Ran 4 power cords to portable test lab

- Used stainless piping to create a probe for FC stack

DCEC hired Eastmount Environmental to perform emissions testing on the fuel cell at the demonstration site under typical startup conditions of the demonstration. Eastmount utilized a portable laboratory, which housed gas analysis equipment, calibration equipment and gases, and data recording equipment. Eastmount also did flow rate measurements that, when combined with the composition analysis, could be used to calculate total emissions rates for all the measured stack gas constituents.

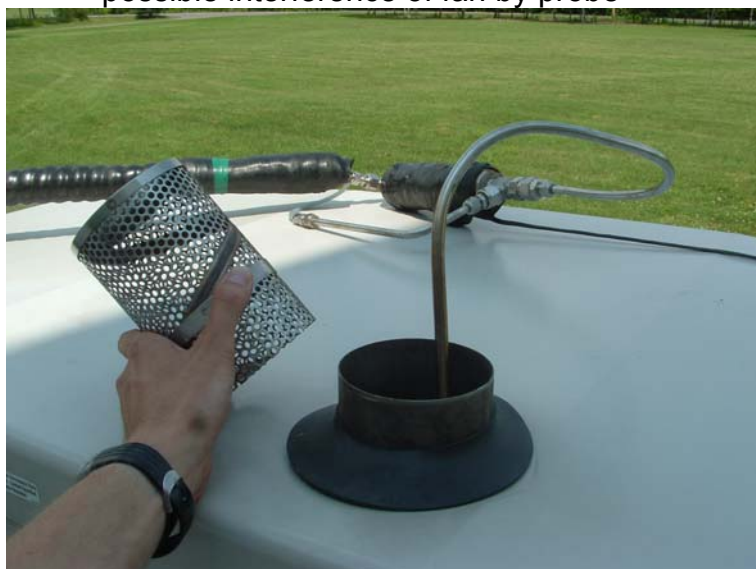
- Powered on FC ~8:55 AM
- Checked comms with FC good
- Removed FC stack cover and inserted test probe into stack after checking for possible interference of fan by probe

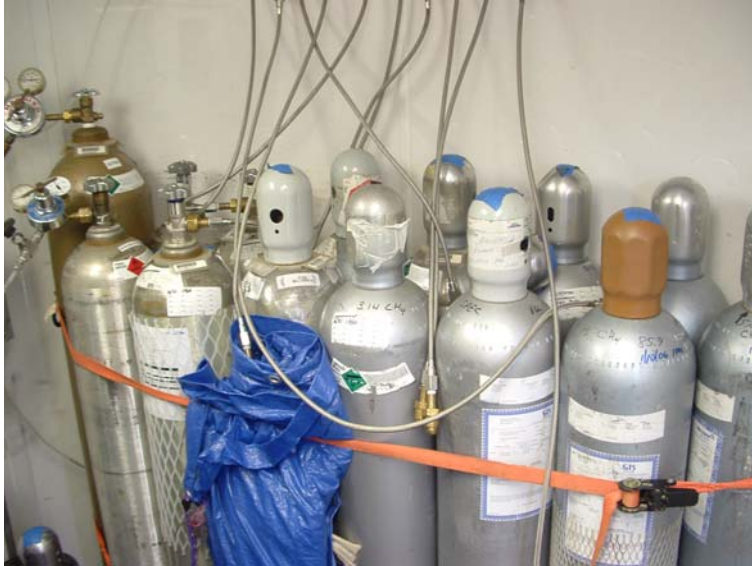
- Checked for leaks, then vacuum in test line
- ~9:30 AM began calibration of test gear with calibration gases Dave brought with him
 - First ran gases directly into instrument
 - Then ran calibration gases through loop including the entire tube from the test probe back to the test lab

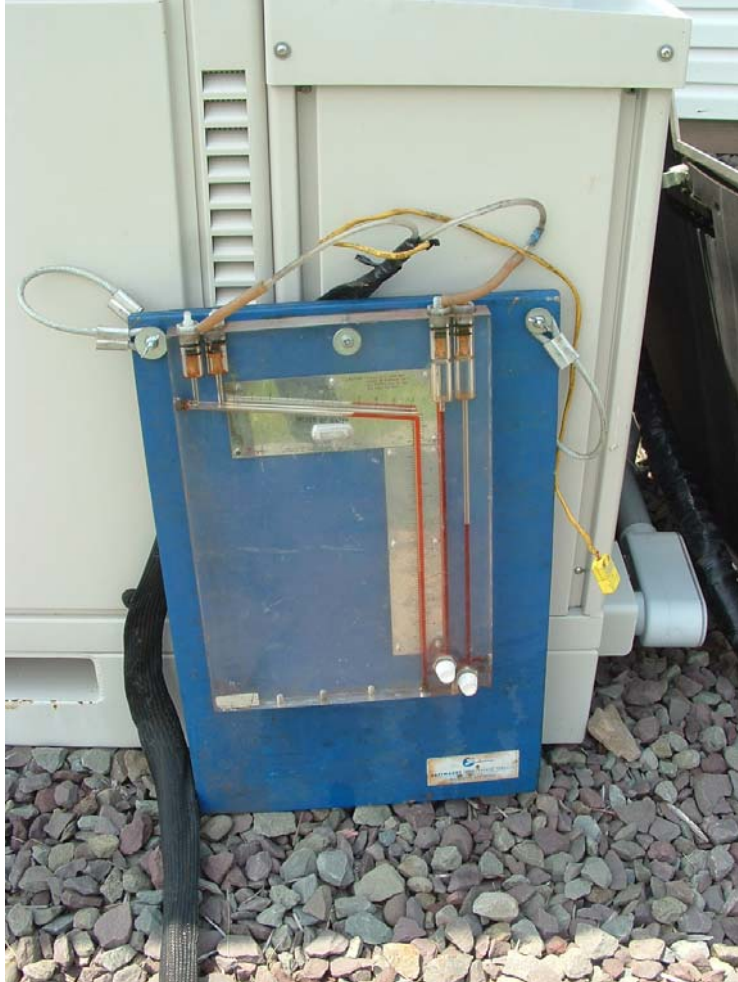
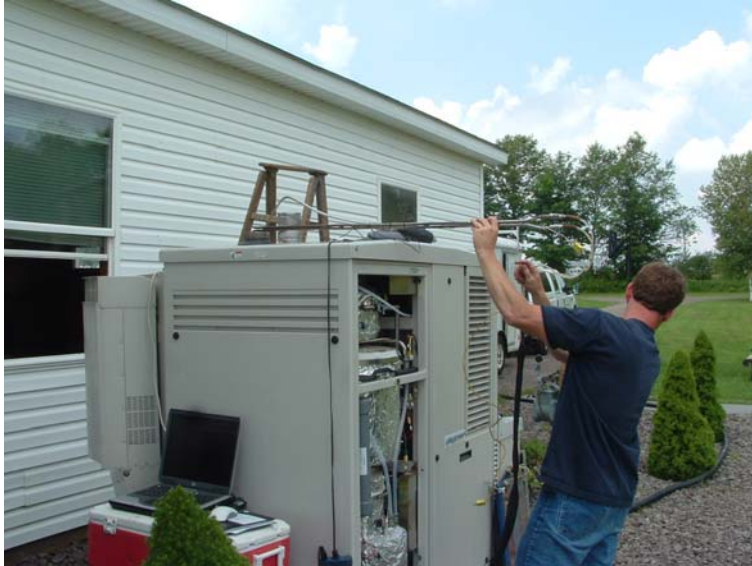
- ~1:30 PM the Reformer state changed to ATO flow
- ~1:31 PM the Reformer state changed to Purge state
- ~13:29 (Eastmount system time) on Dave's data we noted that the total hydrocarbons peaked above 100 ppm range, so Dave switched to the 1000 PPM scale. We may have lost 1 or 2 minutes of THC data in transition between 0-100 PPM range and 0-1000 PPM range.
- Between 1:40 and 1:45 PM took flow measurements in the stack
 - 87 degrees
 - 29 molecular weight assumed

- Validated flow measurement with separate S-type flow measurement device
- Stack temperature at 3:02 PM was 150 degrees F
- 3:21 auto shutdown and restart by FC
- ~3:23 PM manual shutdown by Schneider
- Dave re-ran system calibration
- Left site ~4:00 PM

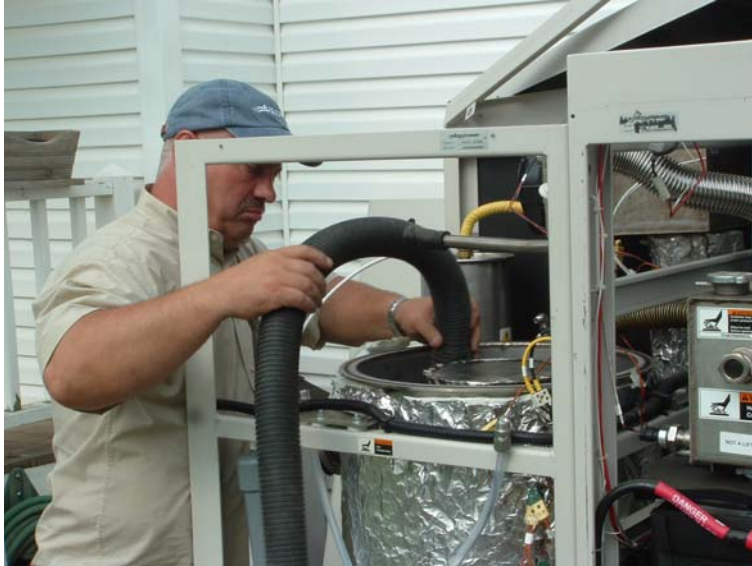
- Arrived ~7:30 AM
- Powered up FC to get last event and stats logs
- Disconnected AC power at outdoor manual disconnect
- Morawski disconnected batteries
- Moved fuse to spare position
- Pietrantonio disconnected and partially drained the thermal protection for the water line
- Disconnected and partially drained the CHP loop
- Turned off propane at meter and tank
- Pietrantonio disconnected propane from FC
- Morawski removed catalyst, but it was still warm from running yesterday so he was a little worried about temperature

- Morawski removed the desulf tank
- Pietrantonio drained therminol
- Using boom truck, lifted FC to flat bed truck

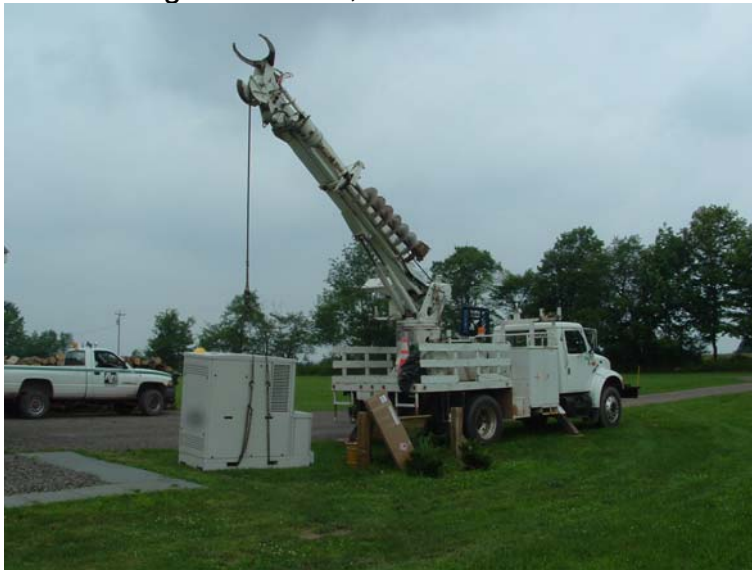
- Also placed hazardous materials in two containers on flat bed truck in front of FC
